SAFETY BULLETIN

Too many underground fires

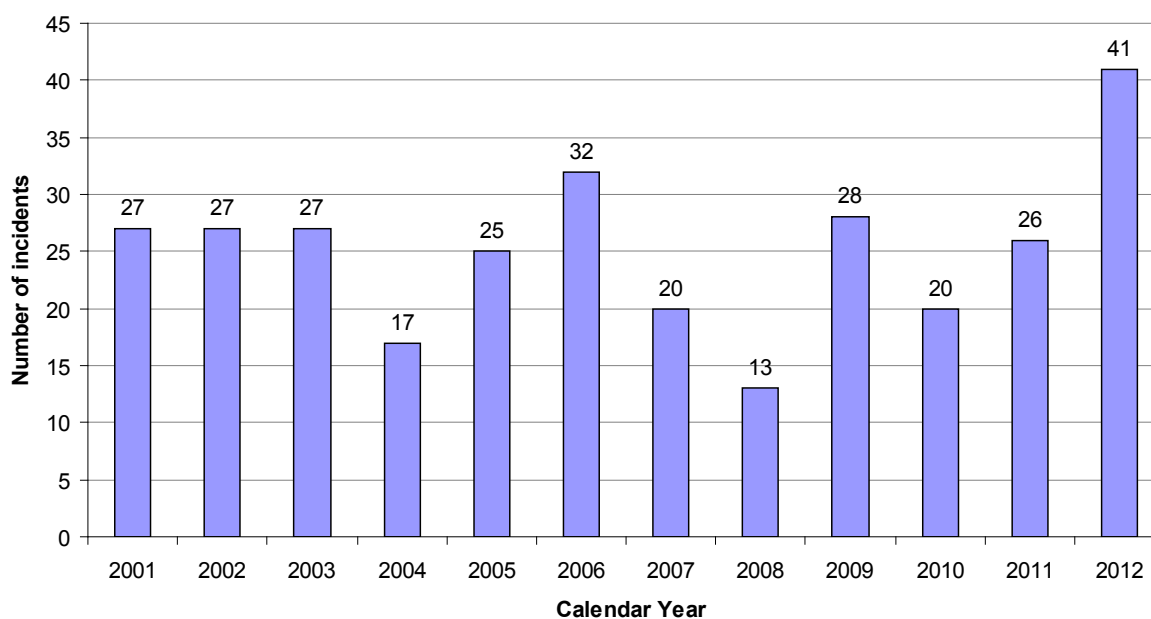
Figure 1 - Fires on mechanical plant at underground metalliferous mines 2001-2012

For the same period there has been a relatively steady increase in the number of fires reported on mechanical plant at underground metalliferous mines (see figure 1).

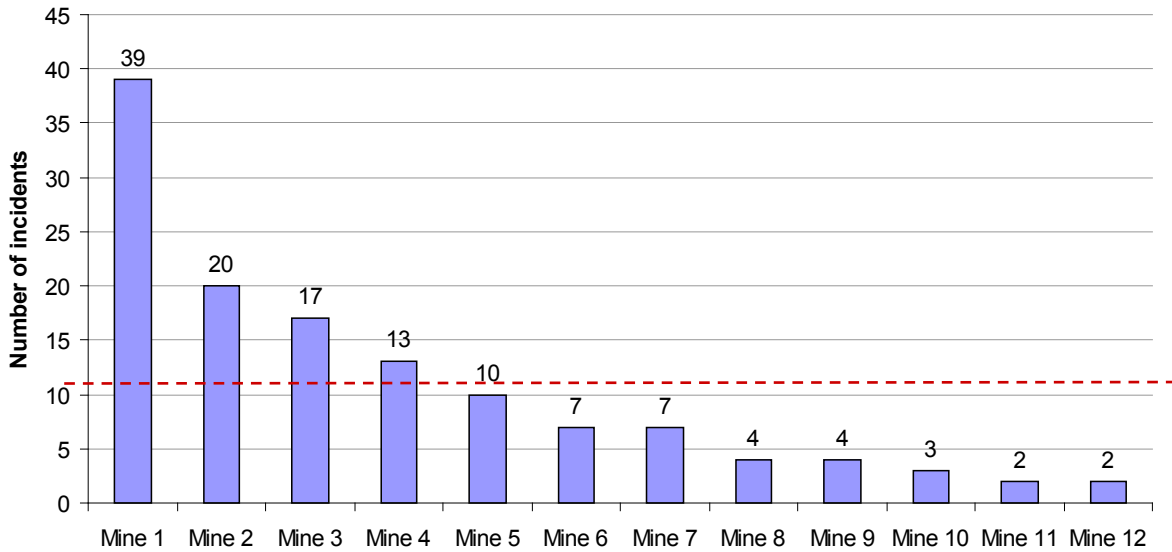
Figure 2 - Fires on mechanical plant at underground metalliferous mines by mine 2008-2012

Figure 2 shows the range of results for some mines.

The greatest number of fires occurred in the Cobar area 70 (55 percent). There have been 45 (35 percent) fires in the Orange area and 13 (10 percent) fires in the Broken Hill area.

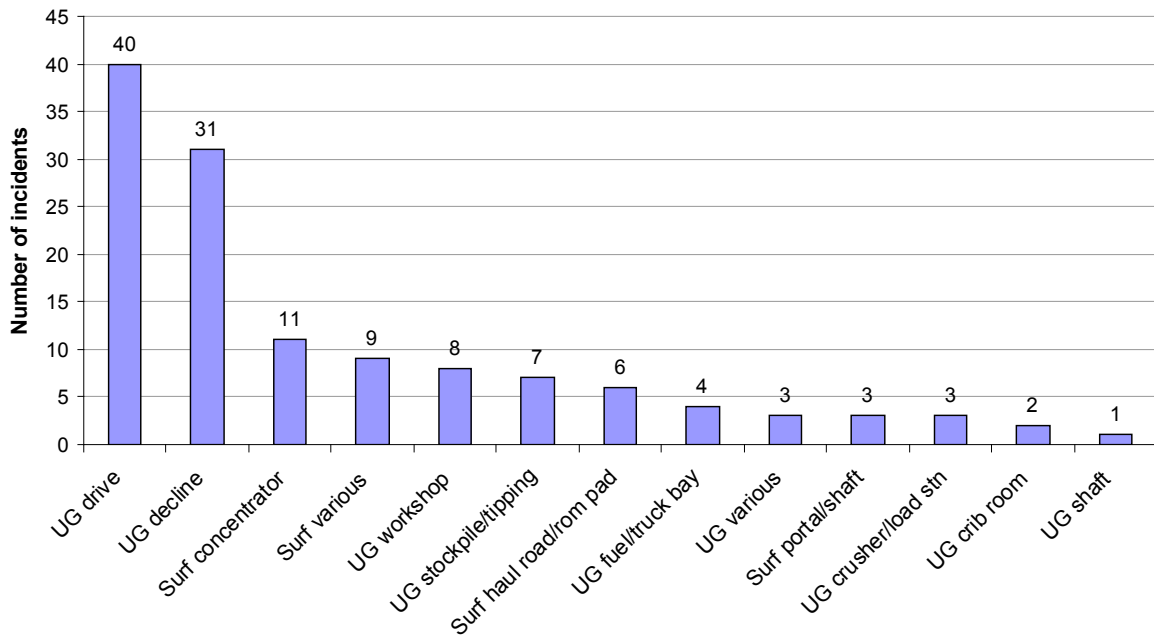
Figure 3 - Fires on mechanical plant at underground metalliferous mines by location of incident 2008-2012

Underground drives and declines were the locations of 71 fires (55 percent), refer figure 3. This is unremarkable given the type of plant being used at these mines and the nature of the work being undertaken.

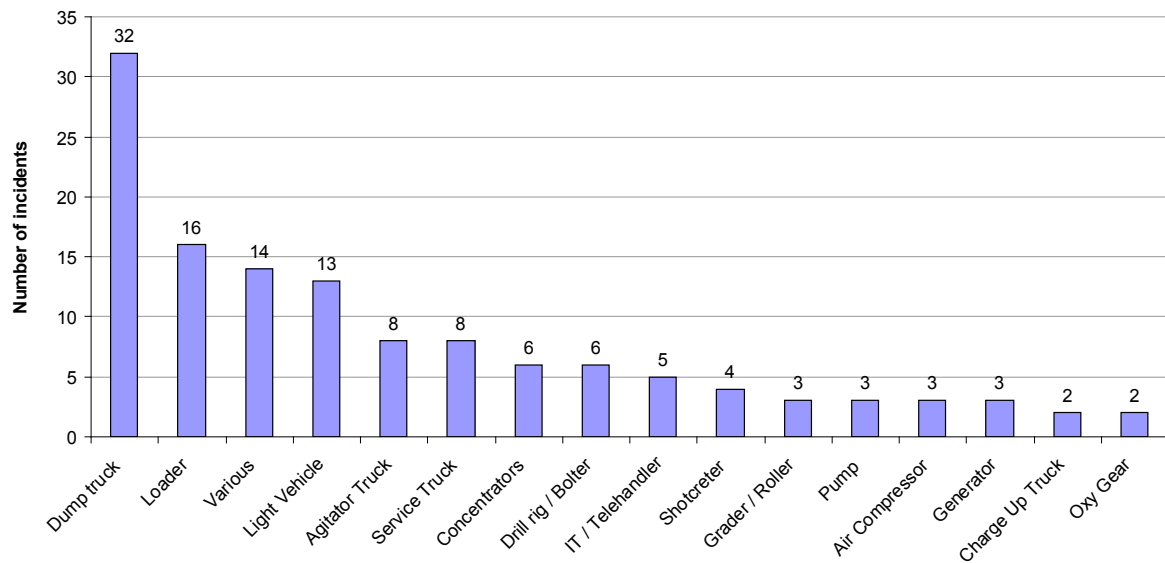
Figure 4 - Fires on mechanical plant at underground metalliferous mines by equipment type 2008-2012

Figure 4 identifies how the number of fires compared for different types of plant.

Dump trucks and loaders sustained 48 fires (38 percent), all other heavy mobile plant combined sustained 36 (28 percent) fires. Light vehicles, which at most mines significantly outnumber heavy plant, sustained only 13 (10 percent) fires.

It appears that the complexity of hydraulic, fuel, electrical and braking systems on heavy mobile plant, and the nature of the work being undertaken, created the greatest potential for damage and for a fire. Data available from COMET was not sufficient to establish if any particular item of plant was particularly prone to fire.

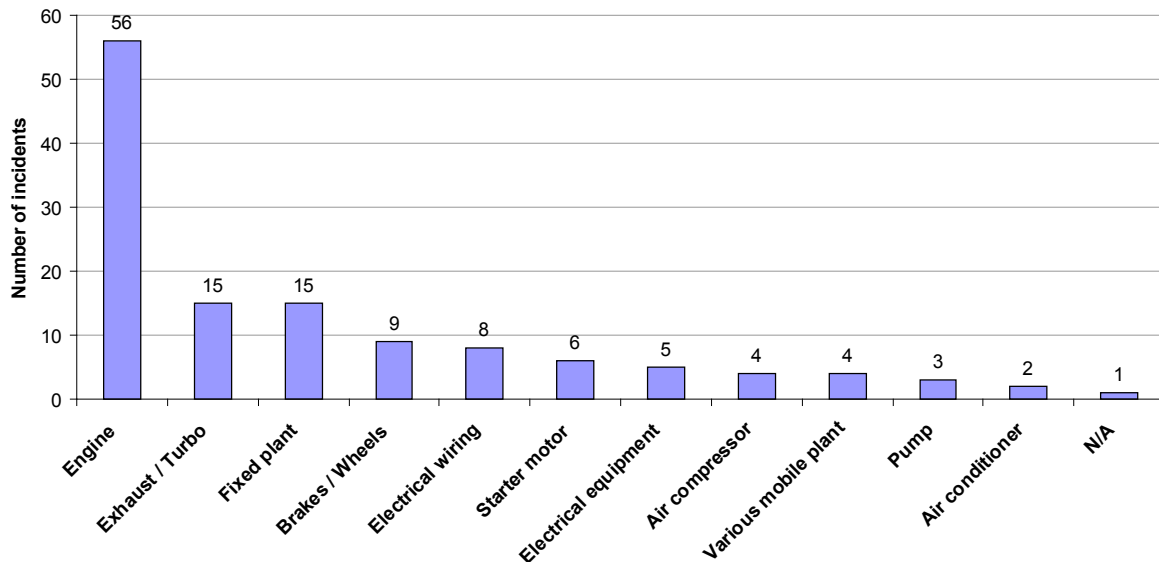
Figure 5 - Fires on mechanical plant at underground metalliferous mines by location of fire 2008-2012

The majority of fires on mechanical plant, 71 (55 percent), have occurred on the engines or exhaust of mobile plant (see figure 5). This result is supported by the data contained in figures 6, 7 and 8.

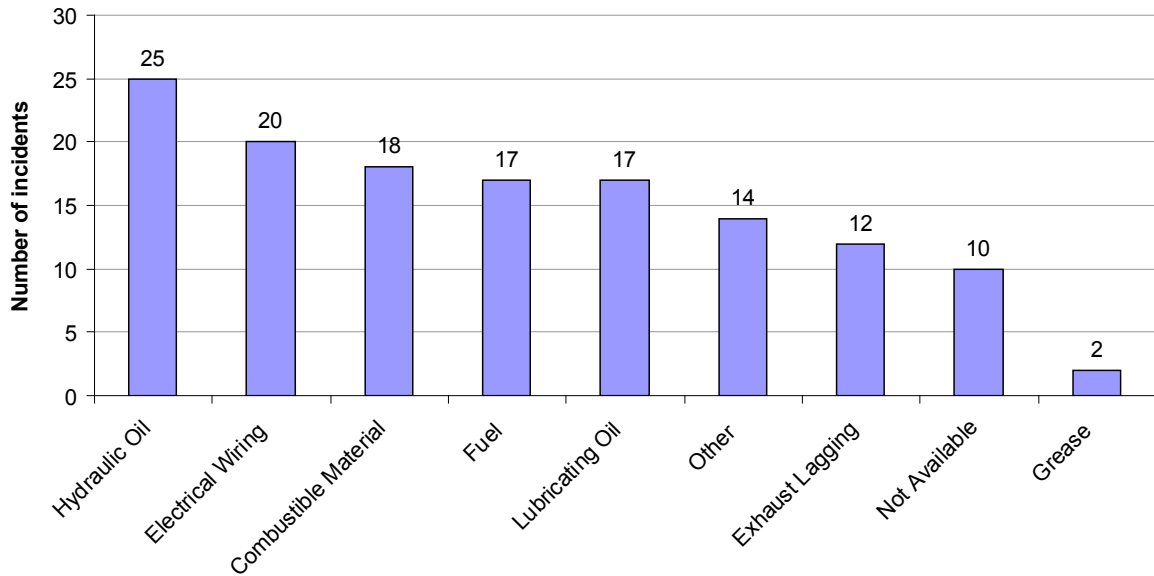
Figure 6 - Fires on mechanical plant at underground metalliferous mines by fuel source 2008-2012

Figure 6 shows the principal fuel source for fires is hydraulic oil, lubricating oil, fuel and grease, which made up 45 percent of the total (68 percent for 2001 to 2007). Electrical wiring made up 15 percent of the total, combustible material; e.g. rags, made up 13 percent of the total and exhaust lagging made up 9 percent of the total. All are significant factors.

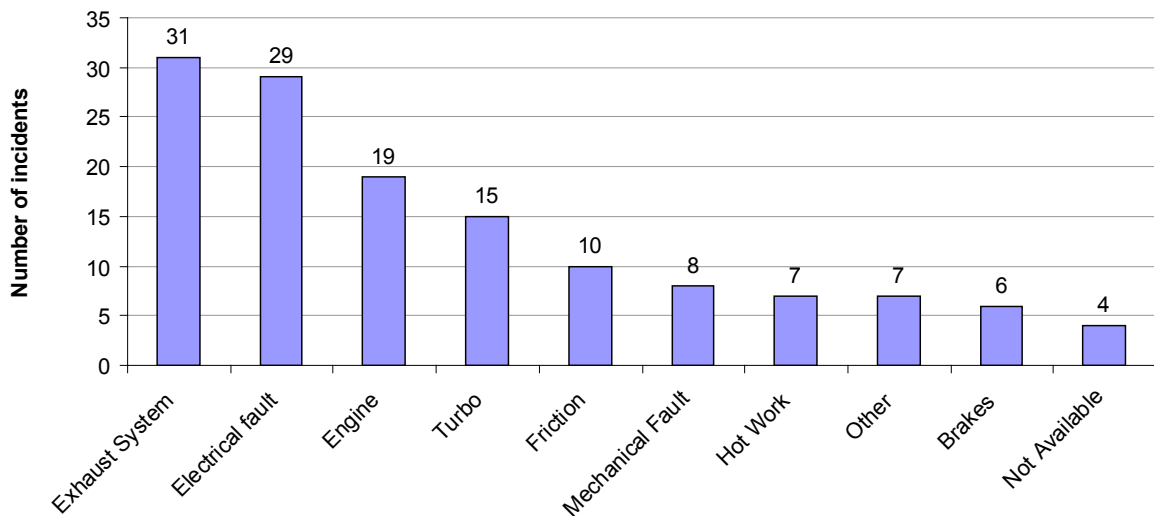
Figure 7 - Fires on mechanical plant at underground metalliferous mines by heat source 2008-2012

Figure 7 identifies the principal heat source for fires is the exhaust system, engine and turbo on mobile plant which made up 48 percent of the total (62 percent for 2001 to 2007). Electrical faults made up 21 percent of the total (14 percent for 2001 to 2007).

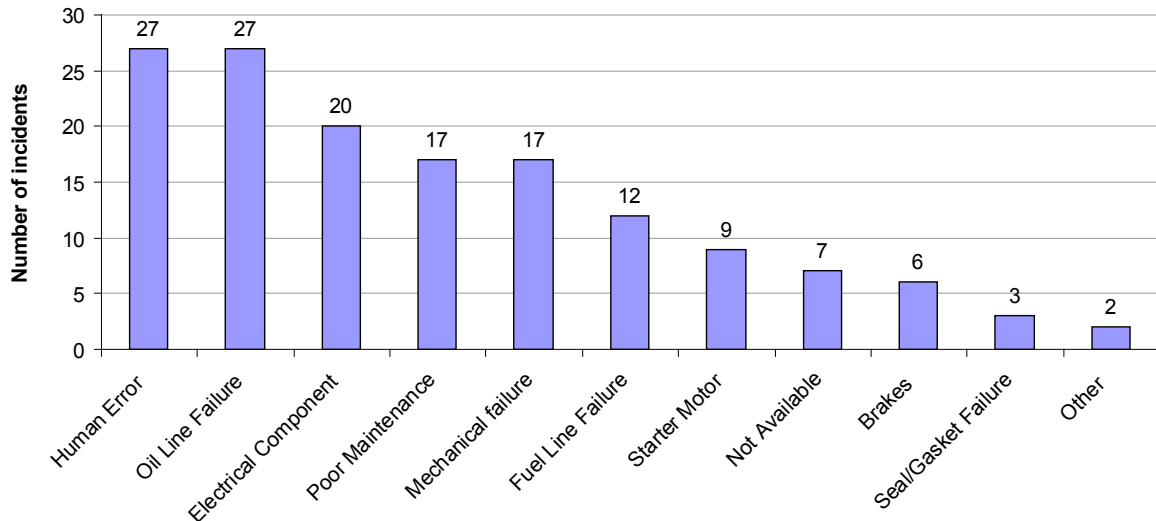
Figure 8 - Fires on mechanical plant at underground metalliferous mines by contributing factors 2008-2012

Figure 8 shows the principal contributing factors for fires are human error and poor maintenance that together made up 30 percent of the total (20 percent for 2001 to 2007). The identification of human error and poor maintenance was made as objectively as COMET data permitted. Oil and fuel line failure made up 27 percent of the total (32 percent for 2001 to 2007) and electrical component failure made up 20 percent of the total (11 percent for 2001 to 2007).

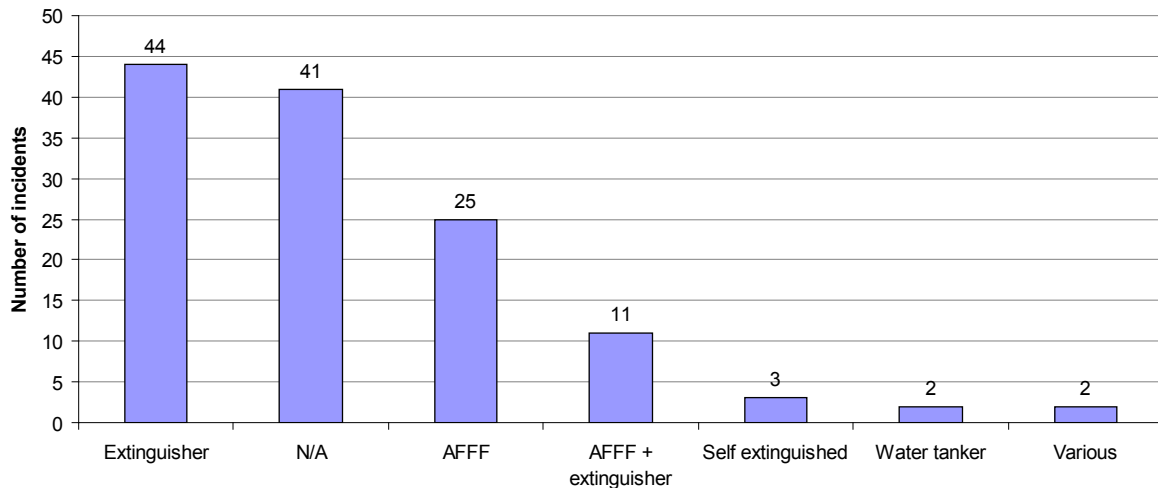
Figure 9 - Fires on mechanical plant at underground metalliferous mines by fire fighting 2008-2012

Figure 9 shows how fires were extinguished. The figure shows most fires were extinguished with hand-held extinguishers 44 (34 percent). AFFF fire suppression systems, generally the safest option for fire fighting on mobile plant, were used in only 25 (20 percent) fires.

Fire suppression systems were used in another 11 (9 percent) fires in combination with a fire extinguisher, which suggests that they did not operate effectively and this conclusion is supported by information contained in some of the corresponding COMET events. However data available from COMET was not sufficient to establish a reliable conclusion regarding fire fighting because 41 (32 percent) COMET events contained no information at all regarding fire fighting.

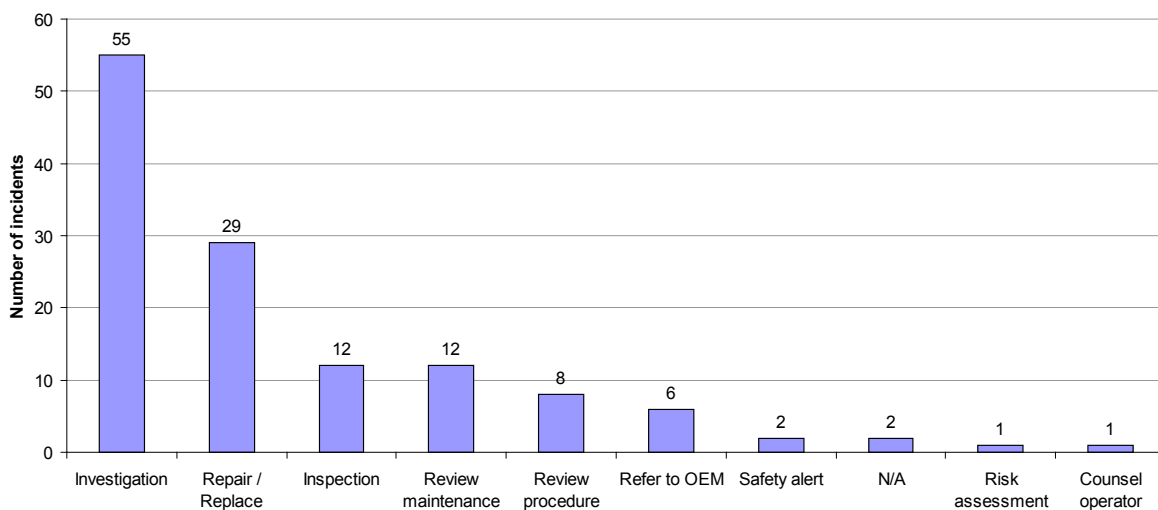
Figure 10 - Fires on mechanical plant at underground metalliferous mines by corrective action 2008-2012

In 67 (52 percent) cases, mines responded to a fire by conducting an investigation or an inspection, refer figure 10.

However in the majority of these cases, data available from COMET was not sufficient to confirm that the cause of the fire was correctly identified and that risk management principles were applied to select and implement appropriate control measures. In 29 (23 percent) cases, mines determined that to repair or replace damaged components was sufficient corrective action and there was no indication that an investigation was completed. In another 29 (23 percent) cases, mines responded by undertaking risk assessments, reviewing operating and maintenance procedures, consulting the OEM and issuing safety alerts.
