**NSW
Resources
Regulator**

Quarterly safety report

July to September 2020

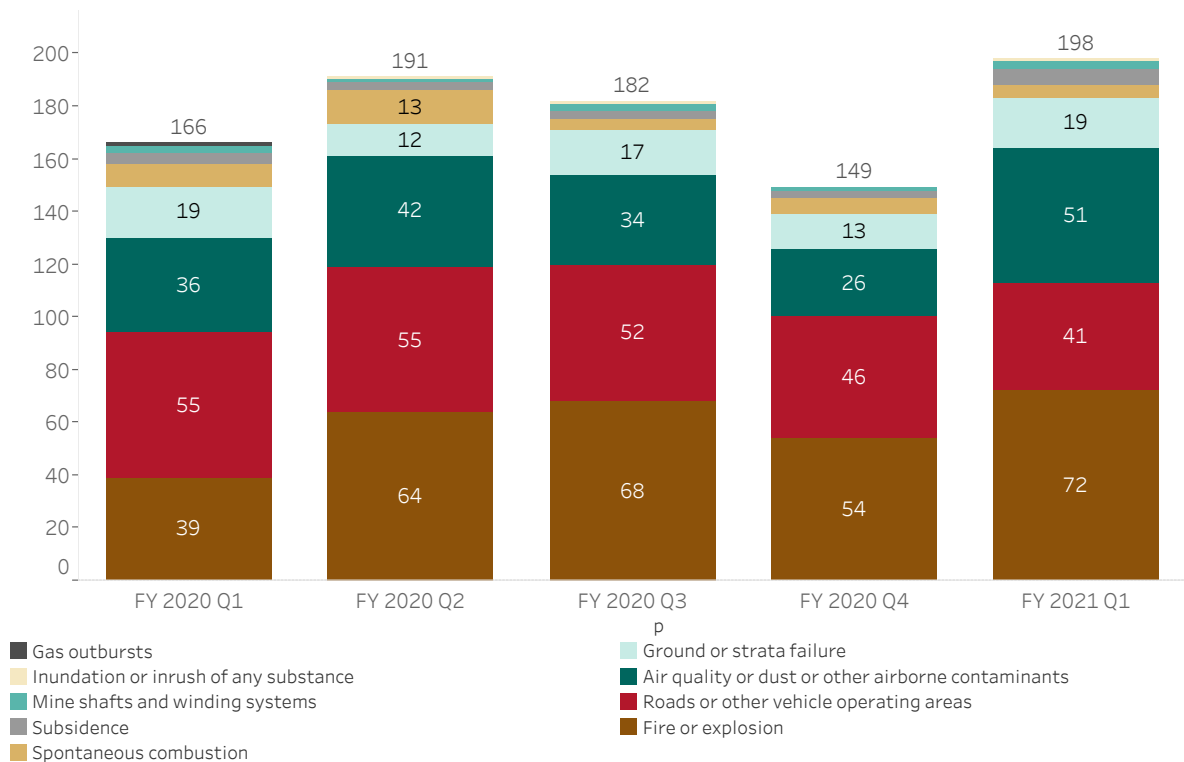
FIGURE 1. INCIDENT NOTIFICATIONS RECEIVED BY PRINCIPAL HAZARD JULY 2019 TO SEPTEMBER 2020

The chart below presents a further breakdown of numbers of incidents notifications received by quarter related to principal hazards as defined in clause 5 of the Regulation.
