COMPLIANCE AUDIT PROGRAM

EL6243 - NARRABRI SOUTH EXPLORATION PROGRAM

Narrabri Coal Pty Ltd

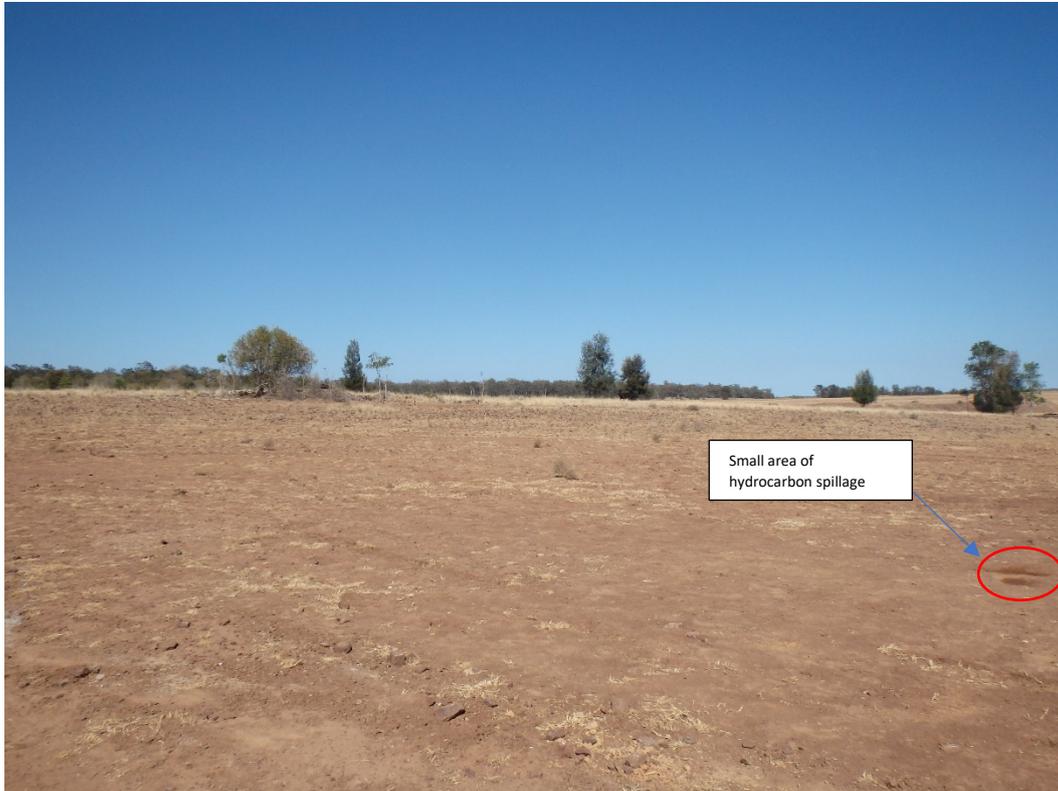
There were no chemicals, fuels or oils on any of the sites inspected. One very minor spill of hydrocarbon material was observed at site NC795 (refer to figure 1) but this would not have been reportable to either the Environment Protection Authority (EPA) or the Regulator, as there was no significant risk of environmental harm.

Figure 1 Site NC795 showing rehabilitation and small area of hydrocarbon spillage

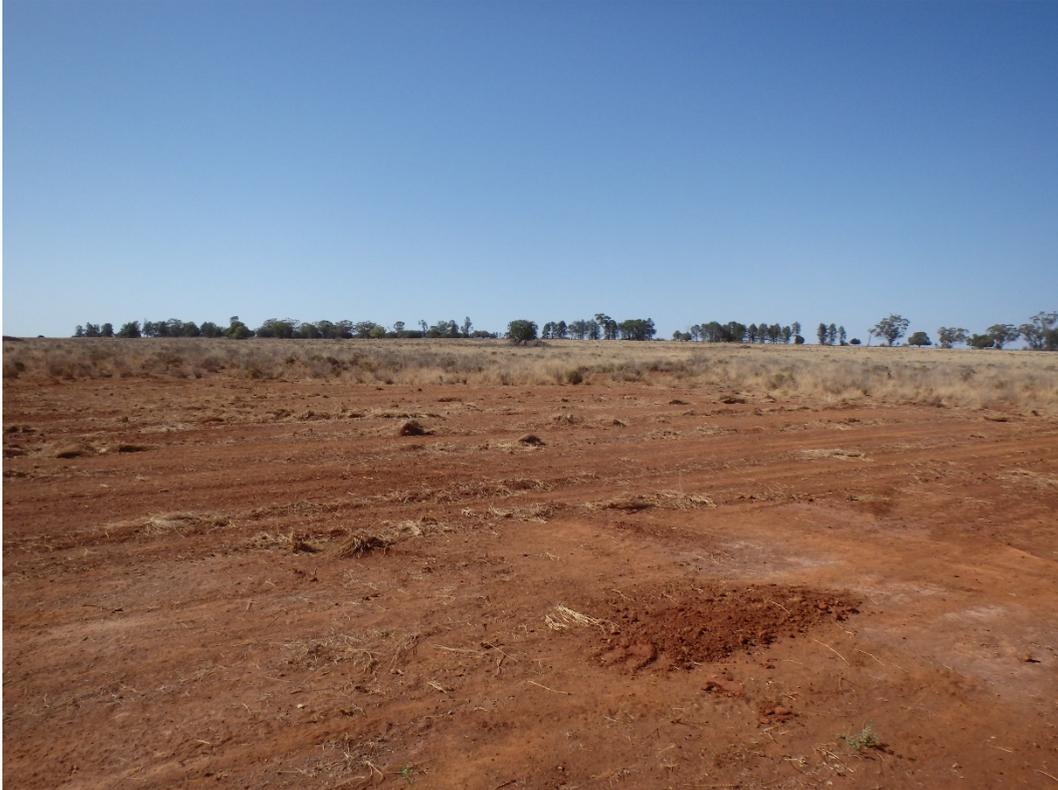
No evidence of erosion and sediment control was observed on any of the four sites inspected. However, it was also noted that these sites were on relatively flat grades, where specific erosion and sediment controls may not have been required (refer to figure 2).

Figure 2 Site NC798 – rehabilitated flat paddock

A review of examples of drill plans provided, with the permits to work, did not show any specific erosion and sediment controls on the plans for any of the sites. No evidence was sighted to indicate that erosion and sediment control plans were prepared for each drill site (or group of drill sites) as part of the site planning process. This is raised as an **observation of concern No. 1**.

OBSERVATION OF CONCERN NO.	DESCRIPTION OF ISSUE	RECOMMENDATION
1	<p>The REF included a commitment to ‘prepare an erosion and sediment control plan to minimise soil disturbance during clearing and accessing the drill pads and incorporate appropriate erosion and sediment control as necessary’. A review of examples of drill plans provided with the permits to work, did not show any specific erosion and sediment controls on the plans for any of the sites. No evidence was sighted to indicate that erosion and sediment control plans are prepared for each drill site (or group of drill sites) as part of the site planning process.</p>	<p>Narrabri Coal should prepare erosion and sediment control plans for each drill site.</p>
2	<p>It was noted that the REF that accompanied the non-CEA application for exploration activities provided very minimal information on rehabilitation strategies and no information on rehabilitation monitoring or completion criteria.</p>	<p>Narrabri Coal should ensure that details of rehabilitation requirements are included in future REFs.</p>

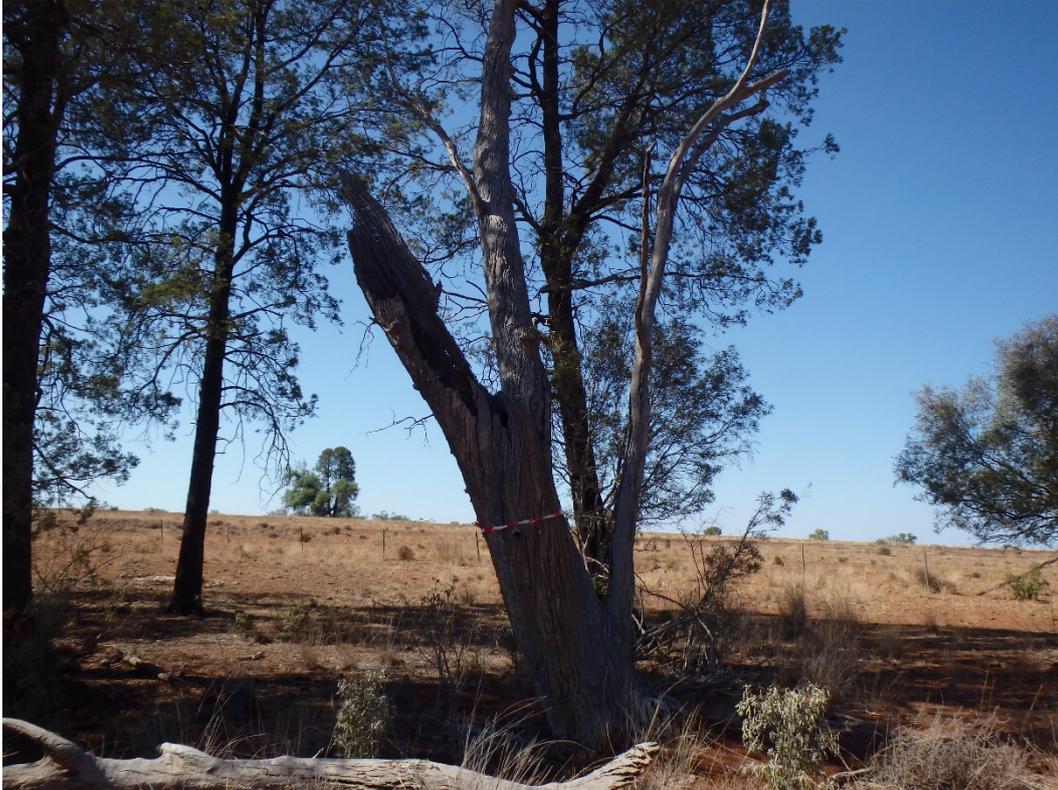
A habitat tree was observed at site NC799 on the edge of the drill site. The tree was marked with flagging tape and had not been disturbed during the drilling activities (refer to figure 3).

Figure 3 Site NC799 showing marked habitat tree

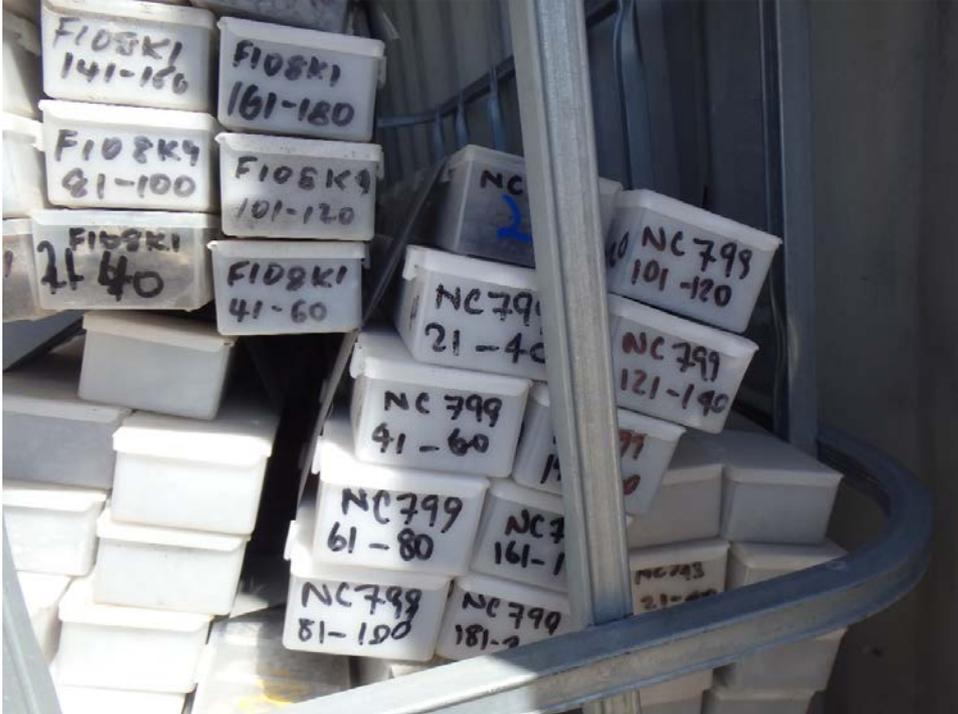
The four holes drilled to date, under the existing approval, were non-cored holes. Chip samples were collected from each hole. These samples were stored in modular plastic chip trays, labelled with tray number, hole number, start and finish depths (refer to figure 4). The chip trays were observed to be stored in metal-framed pods within a shipping container (refer to figure 5) in a hard stand area on site. While the integrity of the samples is generally being maintained, there does not appear to be much organisation to the samples. Locating a particular sample may not be an easy process, as there is no record of which samples are stored in which pod or shipping container. As **suggestion for improvement No. 1**, Narrabri Coal should consider the development of a core and sample storage register to record the storage location for each group of cores and samples.

Figure 4 Modular plastic chip trays – ends labelled with hole number and depth

SUGGESTION FOR IMPROVEMENT NO.	DESCRIPTION OF ISSUE	RECOMMENDATION
1	<p>While the integrity of the samples is generally being maintained, there does not appear to be much organisation to the samples. Locating a particular sample may not be an easy process, as there is no record of which samples are stored in which pod or shipping container.</p>	<p>Narrabri Coal should consider the development of a core and sample storage register to record the storage location for each group of cores and samples.</p>

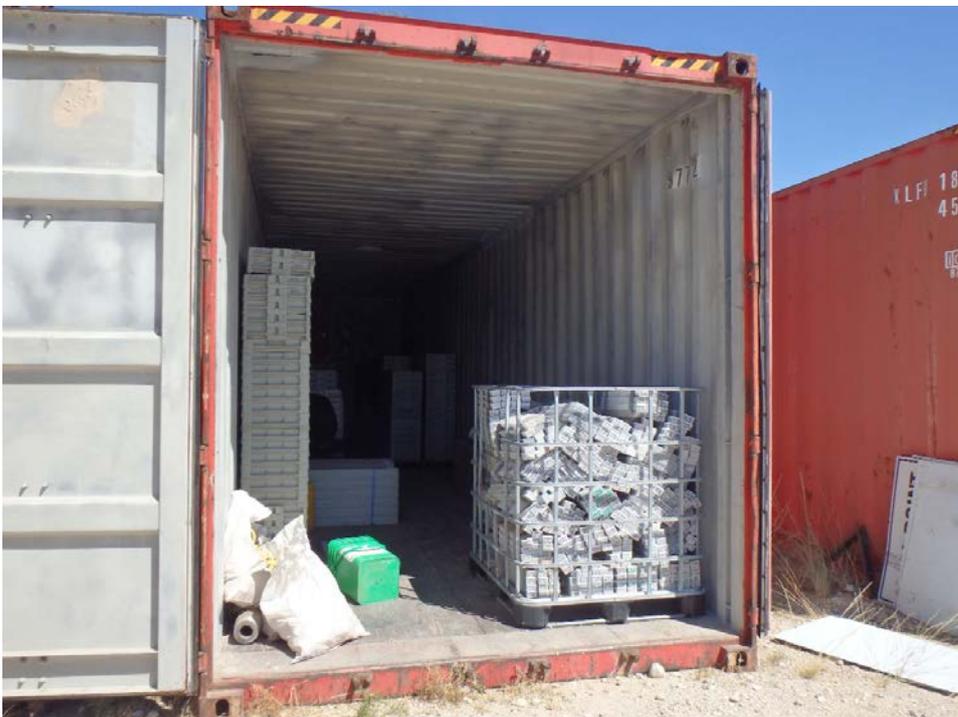
Figure 5 Chip sample trays in a metal framed pod within a shipping container
