WEEKLY INCIDENT SUMMARY

Week ending Friday 30 October 2020

Summarised incidents

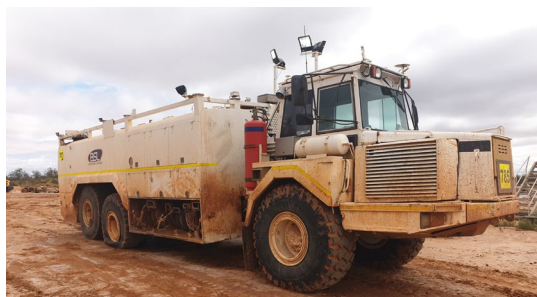
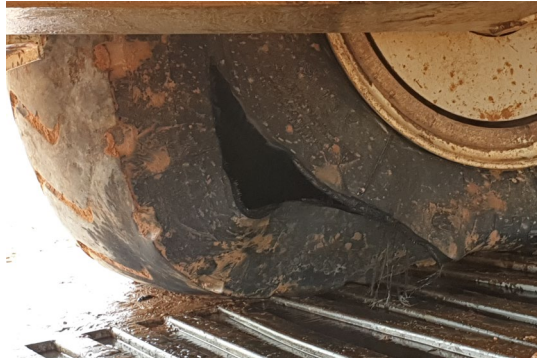
INCIDENT TYPE	SUMMARY	COMMENTS TO INDUSTRY
Dangerous incident IncNot0038535 Mineral sands - dredging	An operator was knocked to the ground when a tyre on a fuel truck blew out. The operator was on the opposite side of the truck to where the tyre blew and was knocked off their feet following the incident. The truck was unladen and stationary at the time and had only travelled 100m from the workshop when the incident occurred.	<p>Tyres should be checked and repaired in accordance with AS 4457.2-2008 Earth-moving machinery - Off-the-road wheels, rims and tyres - Maintenance and repair – Tyres.</p> <ul style="list-style-type: none"> • The life cycle management of tyres should include the changing out of the tyre before failure. • Tyre manufacturers should be engaged to assist with identifying the cause of tyre failure. • Regular visual inspections of tyre sidewalls should be done

to identify bulges, bubbles, cuts or other damage to minimise risk from tyre failure or blowouts.

- Vehicles should not be operated with underinflated tyres.

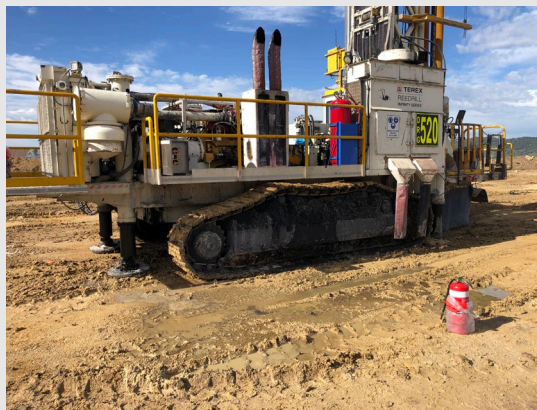
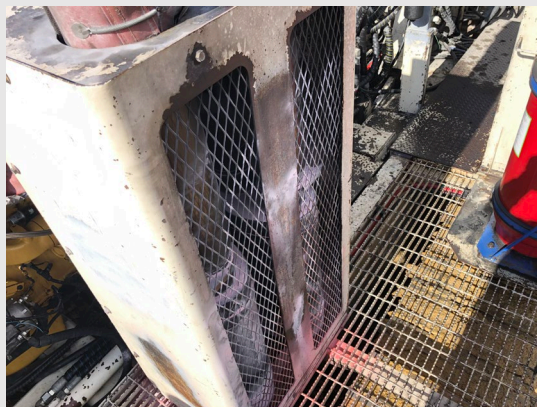
A fuel cart was refuelling a drill rig when a cracked fuel tank sprayed diesel onto the drill rig turbo causing a fire.

Refuelling arrangements for mobile plant should be risk assessed and managed for all mine sites. The potential risk of plant/worker interaction and fire should be controlled.

Mines should check the designs of fuel tanks to ensure they are capable of accepting high delivery flows and can handle the pressure of the refuelling system without deformation of the fuel tank including the maintenance of pressure relief valves.
