WEEKLY INCIDENT SUMMARY

Week ending Friday 21 May 2021

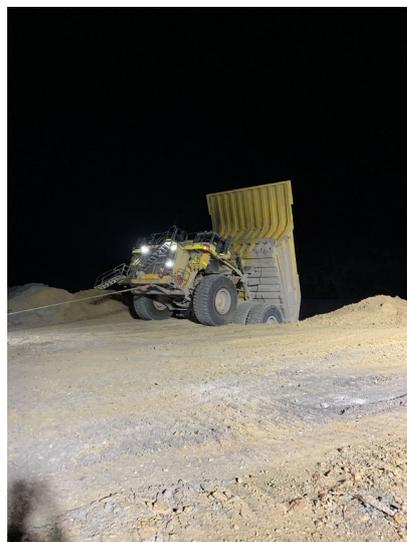
Dangerous incident
IncNot0039909
Open cut coal mine

Both sets of rear wheels on a dump truck dropped approximately one metre when the edge of the dump slumped while the operator was tipping a load.

When designing a dump, ground stability should be a primary consideration. Material consistency, wet conditions and dipping ground stability should be considered. Inspections should verify dump integrity. Areas that do not meet the standard should be demarcated, communicated and remediated to meet the standard.
