# WEEKLY INCIDENT SUMMARY

Week ending Friday 25 June 2021

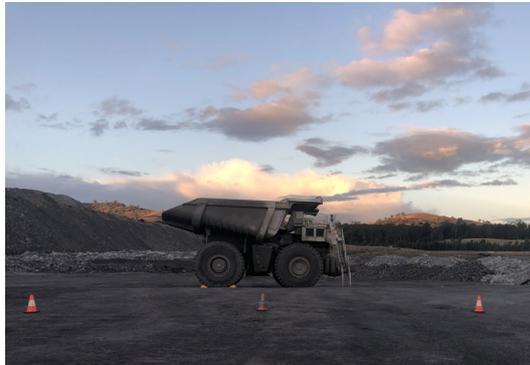
INCIDENT TYPE	SUMMARY	COMMENTS TO INDUSTRY
Dangerous incident IncNot0040141 Open cut coal mine

Roads or other vehicle operating areas	The operator of a dump truck parked on a dump to allow hot seat changeover. The operator was unable to activate the primary access ladder to exit the truck. After several attempts, the operator restarted the truck, exited via the emergency ladder and then activated the ground level e-stop and isolation switch. The truck then rolled forward approximately 50 metres, contacted a windrow and rolled back approximately 17 metres before stopping. The truck was not parked in a fundamentally stable manner.	Changeover between operators should take place at designated park up areas where possible. When this cannot occur, operators should put equivalent controls in place to manage the risk of vehicles rolling away, including fundamentally stable parking.

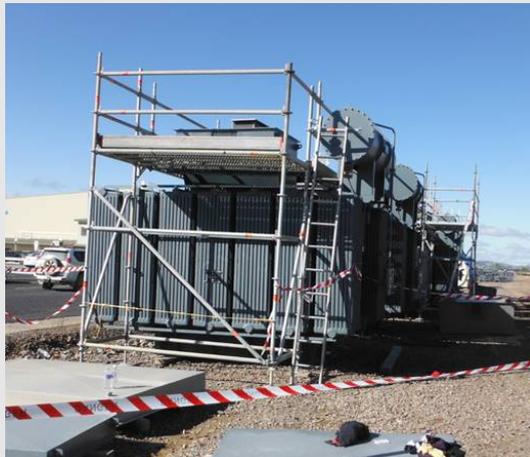
Dangerous incident  
IncNot0040165  
Metals processing

A rigger had completed lift activities and was dismantling a scaffold. While climbing onto the ladder, the rigger ducked under a handrail, missed the first step and fell three metres to the ground. The rigger was not wearing any fall protection equipment.

Mine operators must ensure that there are effective controls in place to manage the risk of falls while climbing on and off scaffolding ladders. All workers, who install or work on scaffolding, should be familiar with site scaffolding procedures. This should include design and construction requirements and necessary safety equipment, such as fall protection equipment.
