SAFETY BULLETIN

DATE: MARCH 2021

Fires occur while refuelling plant

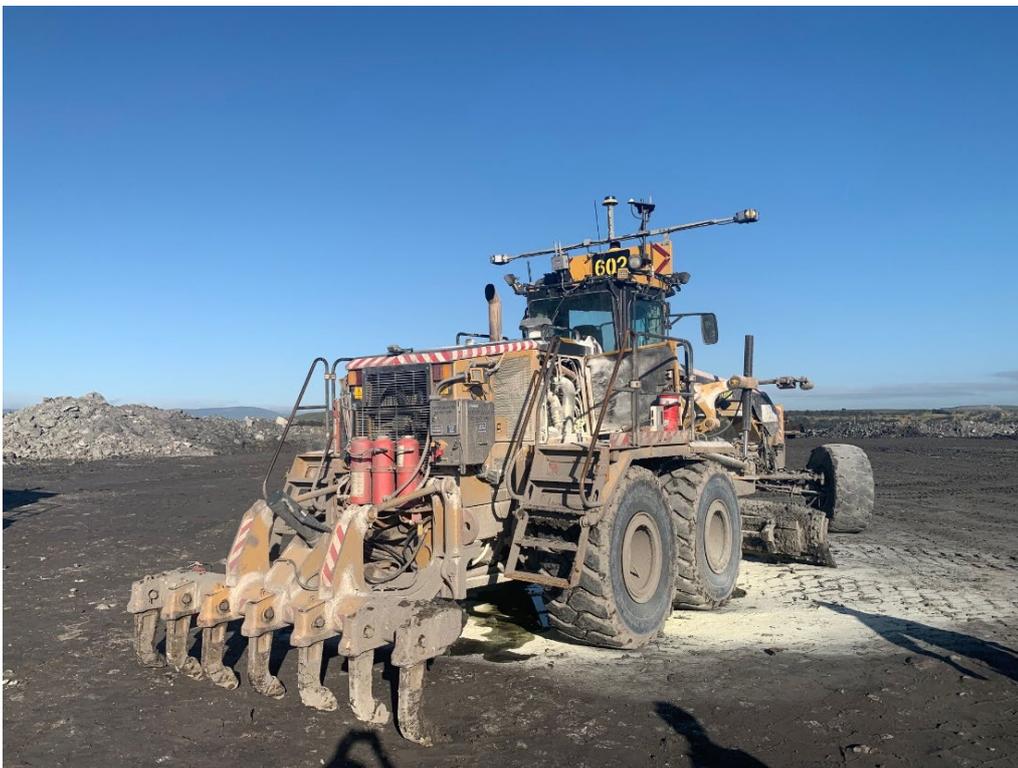
Since August 2017, a total of eight fires have occurred while equipment was being refuelled. In the past six months, the NSW Resources Regulator has been notified of three fires occurring on mobile plant during the refuelling activity, where the cause or significant contributing factor was the failure of the level control breather assembly.

Figure 1 - Fire occurred during refuelling

It is recommended mine operators and equipment owners should:

- Develop an asset list of all fixed and mobile plant that require refuelling with liquid hydrocarbon (e.g. diesel, petrol) products.
- For the identified plant:

- assess the fuel tank breather location to ensure escaping fuel is directed safely away from hot surfaces and other potential ignition sources
 - inspect or test the fuel tank cap to confirm it is fit for service and able to remain liquid tight for expected service pressures from the fuel delivery system

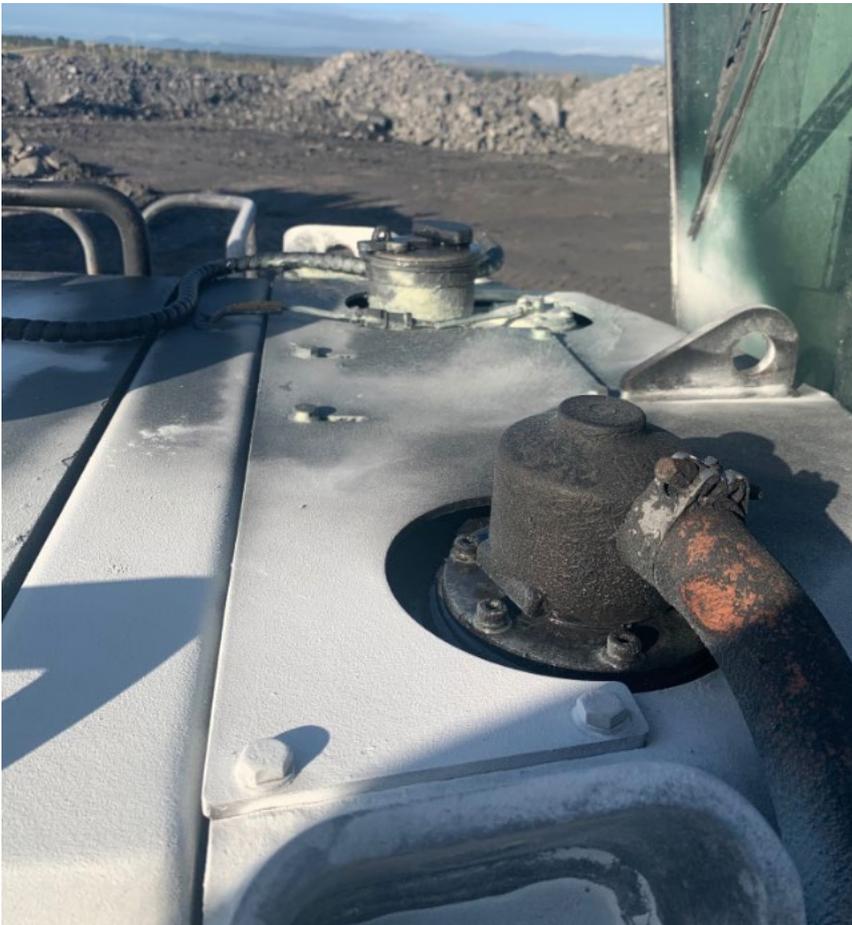
In one incident involving a rear dump truck at an open cut coal mine, the breather check valve did not close and allowed the tank to over fill. This enabled diesel fuel to escape from the breather and ignite on contact with nearby hot engine parts.

In two other incidents at an open cut coal mine, fuel escaped from the vacuum vented fuel tank cap (splash fill point) on identical model graders after the tank was overfilled and pressurised, resulting in a fire.

Figure 2 - Level control vent and filler cap

- mechanical failure of fuel tank level control vent assembly
- inaccurate fuel gauges
- placement of fuel tank vent breather valve near hot engine components
- over pressurisation of the fuel tank by the fuel delivery system
- leaking of the fuel cap where the leaking fuel can flow by gravity or be blown on to hot engine parts
- cracked or leaking fuel tanks or delivery hoses
- inadequate decanting methods or decanting equipment that was not fit for purpose.

- inspect fuel level gauges are installed and reading accurately.
- Review maintenance management systems to include lifecycle maintenance of fuel tank level control vent assemblies and fuel tank caps. The maintenance regime should consider the OEM recommended actions and site operating environmental conditions.

- Review the design of plant to ensure fuel tank breathers, vents and caps are located such that any fuel released is directed safely away from hot surfaces and other potential ignition sources.
- Potential mechanical failure modes and reasonably foreseeable human errors are considered in the design of fuel tanks, caps, vents and refuelling processes.
- Provide adequate information regarding the inspection, testing, specifications and lifecycle recommendations, so the onboard fuel storage system may be used and maintained to be without risk to health and safety when used for the purpose for which it was designed.
- Introduce product improvements to refuelling systems with regard to fire prevention are offered to customers.
