# WEEKLY INCIDENT SUMMARY

Week ending Friday 23 April 2021

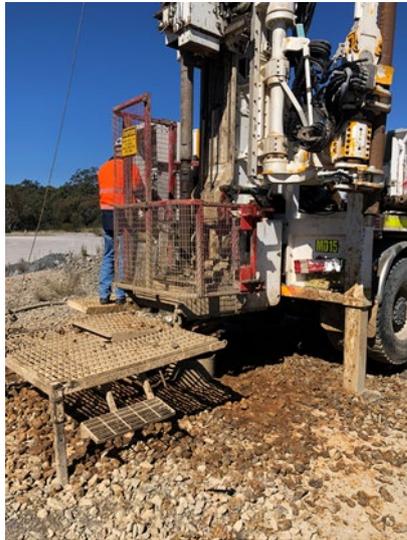
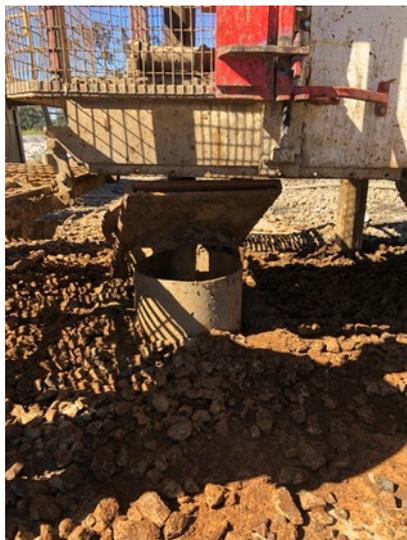
INCIDENT TYPE	SUMMARY	COMMENTS TO INDUSTRY
Dangerous incident IncNot0039697 Underground coal mine	While attempting to unblock a ballast borehole, a surface drill-rig operator and his offsider were hit on the legs with ballast that ejected from the borehole. The preliminary investigation suggests that the rig had drilled down through ballast in the hole and partly into the blockage. A build-up of air pressure caused the loose ballast to dislodge a protective collar, escape and hit the operators. No injuries were sustained.	Drill rig operators need to identify all potential hazards associated with all energy sources and implement appropriate controls. This is especially important when there is the potential for stored energy associated with blockages to be released without warning.

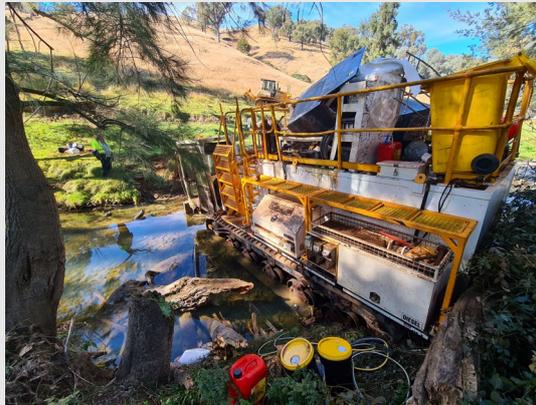
Dangerous incident  
IncNot0039716  
Metals exploration

The operator of a 20 tonne tracked support vehicle sustained lower back injuries when the vehicle lost power on an incline and rolled backwards before coming to rest on a creek bank. The preliminary investigation suggests that the braking system failed to stop the vehicle and there was no fail-safe braking system.

The cause of this incident is unknown at this stage. Further information may be published later. Mine operators are reminded that they must develop and adhere to strict inspection and maintenance standards and practices to ensure plant is fit-for-purpose. Vehicle operators must carry out pre-start inspections to ensure plant can be safely operated. Safety critical systems, such as braking, should be inspected, maintained and tested in accordance with the

manufacturer's recommendations.
