## Safe systems of work for mobile plant

This safety bulletin provides safety advice for the NSW mining industry.

CM9 reference	PUB18/158
Mine safety reference	SB18-07
Date published	16 April 2018
Authorised by	Garvin Burns, Chief Inspector

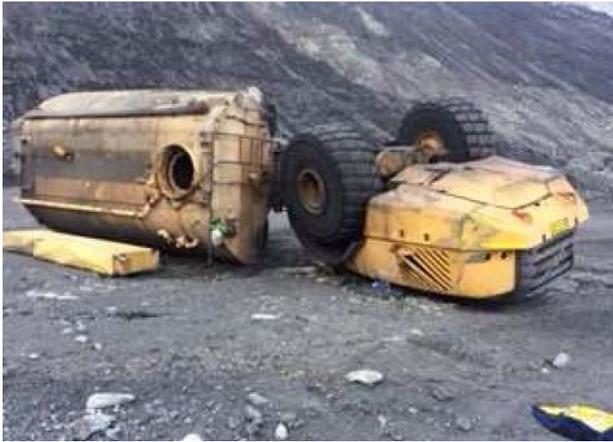
Figure 1: The water truck that rolled over.

On 2 April 2018, a Volvo A40E water truck was travelling down a ramp and making a right-hand turn when the operator lost control. The truck rolled over causing substantial damage to the operator's cabin. This resulted in a significant back injury to the operator.

- review systems of work for the operation of mobile plant, specifically addressing the training, assessment and ongoing maintenance of competency of plant operators

- specify that suitably rated rollover protection and falling object protection structures are fitted to mobile plant
- review the system for introduction of mobile plant to site, with reference to rollover protective devices, access systems and maintenance of safety critical systems

- arising from any incident involving plant, and in accordance with clause 10 of the Regulation, must review and revise the control measures, where it has been identified that control measures were inadequate, deficient or ineffective. The review of controls should address whether the controls:

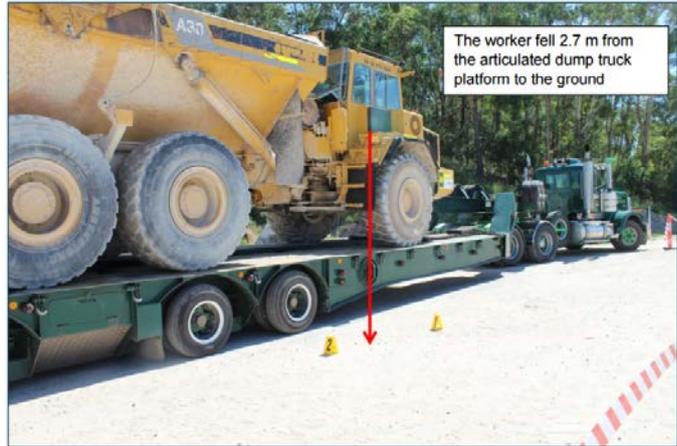
Figure 2: The access ladder where the worker fell.

In February 2016, a worker fell 2.7 m from the platform of an articulated dump truck (ADT) and suffered serious head injuries, which resulted in permanent incapacitation. The dump truck was on a low loader road transport truck and was being prepared to be reversed off the low loader.

- review systems of work for the maintenance and inspection of mobile plant, specifically addressing the provision of safe access systems, including guard rails for platforms and walkways, and the ability to maintain three points of contact when accessing and egressing from mobile plant
