WEEKLY INCIDENT SUMMARY

Week ending Friday 02 April 2021

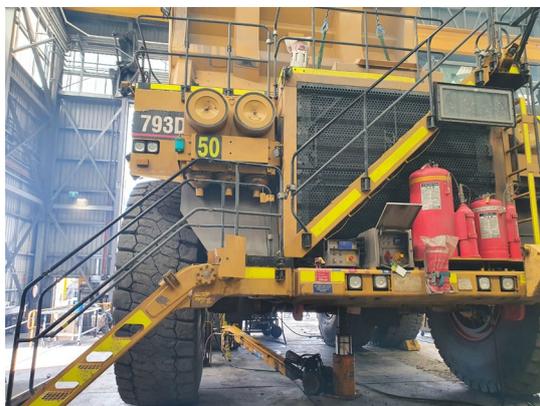
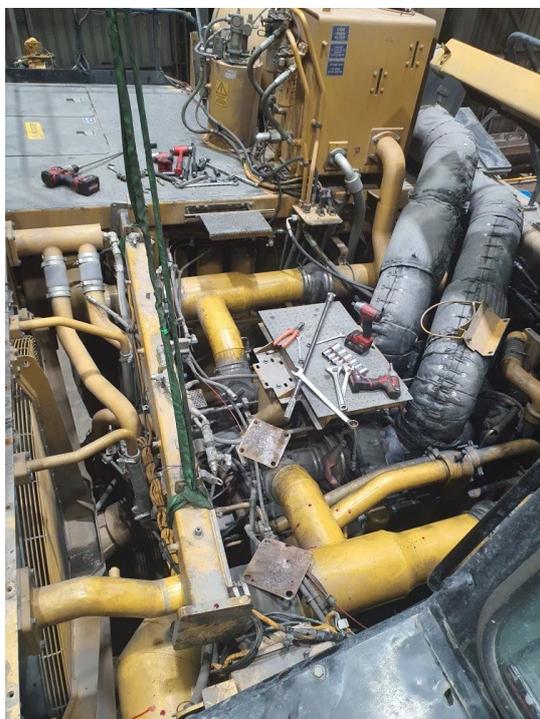
INCIDENT TYPE	SUMMARY	COMMENTS TO INDUSTRY
Dangerous incident IncNot0039537 Open cut coal mine	<p>A fitter received a severe laceration to his left cheek while removing a cross-member from the engine bay of a haul truck. Two fitters were removing the cross-member by jacking from below and lifting with a crane.</p> <p>The injured worker was reportedly moving electrical cables from the path of the cross-member when it came loose. The tension applied by the slings, combined with the pressure from the jack, allowed the cross-member to rise-up quickly and strike the fitter.</p> <p>The incorrect procedure was being used for the task.</p>	<p>Mechanical engineering control plans must set out the control measures for risks associated with the unintended release of mechanical energy by considering safe work systems for people dealing with plant or structures. Mine operators should review how workers and supervisors are trained to recognise the potential hazards associated with all energy sources, including the load introduced by lifting equipment on plant. This is especially important when there is the potential for stored energy to be released without warning.</p>

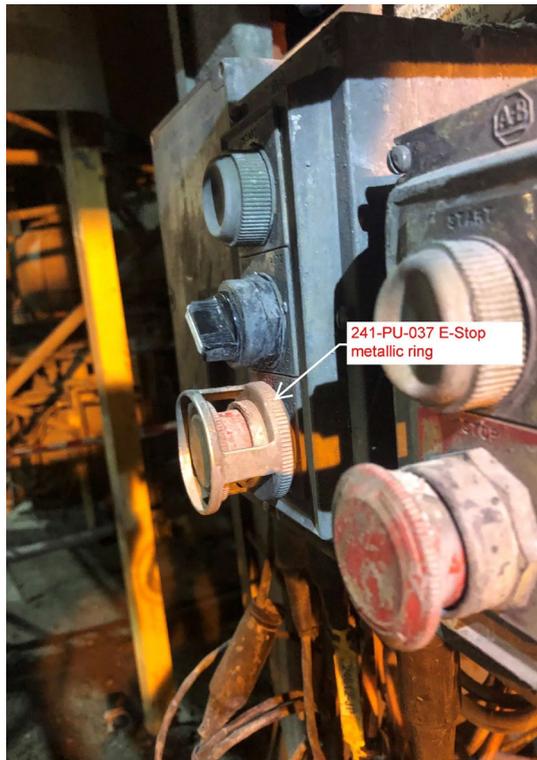
A worker received an electric shock from a metal ring surrounding an emergency stop button on a pump control panel. The worker was attempting to start the pump and had one hand on scaffolding and the other hand pushing the start button. He brushed against the metal ring surrounding the e-stop button and received an electric shock. The control panel is powered by 110 volts and has a non-metallic enclosure. Its ingress protection (IP) failed, which allowed water into the enclosure.

IP rating is critical in areas with the potential for water ingress and should be maintained as fit-for-purpose throughout its life cycle. Mine operators should consider the use of extra low voltage control systems where possible to mitigate the risk of electric shock in the event of IP failures.
