SAFETY ALERT

Worker knocked off ladder

This safety alert provides safety advice for the NSW mining industry.

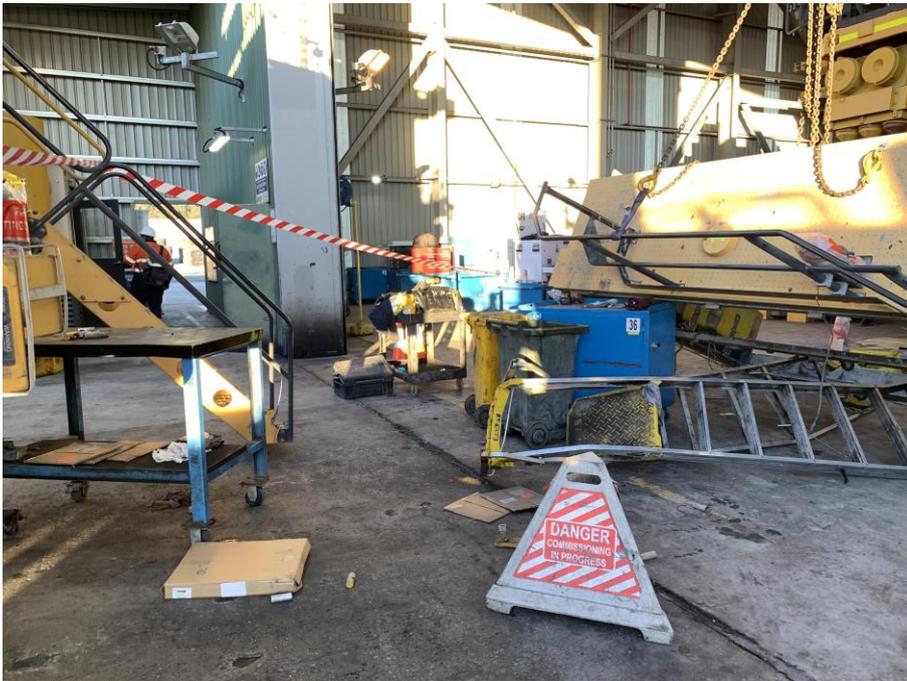
The rear of the attenuator was connected via chains to the overhead crane. A worker placed a platform ladder in front of the radiator attenuator and commenced connecting a sling to the guard rail on top of the attenuator. Whilst securing the sling, the attenuator fell forward, knocking the worker off the ladder onto the mobile workbench. The attenuator fell onto the worker's toolbox, crushing the ladder.

Figure 1: Scene after the incident

Note. The work bench on the left of the picture that the worker fell onto has been moved from its original position.

- Mine operators carry out a risk assessment regarding lifting activities undertaken onsite. The risk assessment should include the transport, storage and stability of loads. In carrying out the risk assessment for lifting activities, the mine operator must implement controls in accordance with the hierarchy of control measures as required by clause 35 and 36 of the Work Health and Safety Regulation 2017.
- When storing plant and equipment, even temporarily, the stability of the item must be considered.
- Lifting procedures provided by manufacturers or designers are to be readily available to workers who are carrying out lifting activities.

- Mine operators provide training to all workers (including contractors) about the hazards of lifting activities and the safe storing and restraining of plant and equipment.
- Mine operators should have risk management procedures in place which require workers to review the hazards associated with a task when the work process changes.
