WEEKLY INCIDENT SUMMARY

Week ending Friday 13 August 2021

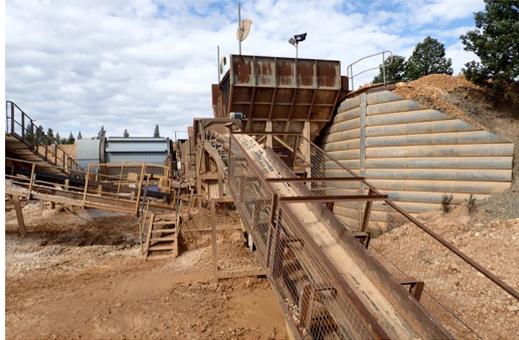
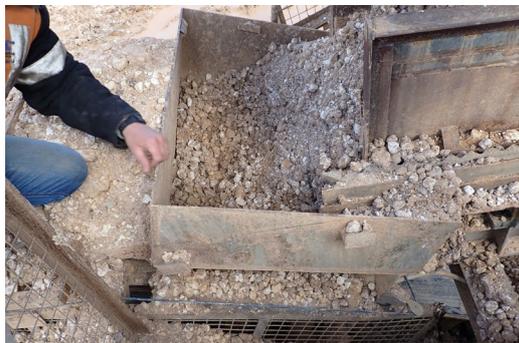
INCIDENT TYPE	SUMMARY	COMMENTS TO INDUSTRY
Dangerous incident IncNot0040477 Open cut mine	A worker was attempting to rectify a jammed conveyor belt when he slipped and fell into the feed chute of the conveyor. The worker was engulfed as the plate feeder continued to feed material from the hopper. A loader driver, operating nearby, heard the trapped worker yelling for help and stopped the plate feeder. The operator then freed the trapped worker from the chute. The worker suffered internal injuries.	This incident is under investigation. Further information may be published later.
