**NSW  
Resources  
Regulator**

**COMPLIANCE AUDIT PROGRAM**

# **EL8153 SUGARLOAF PROJECT**

**Krakatoa Australia Pty Ltd**

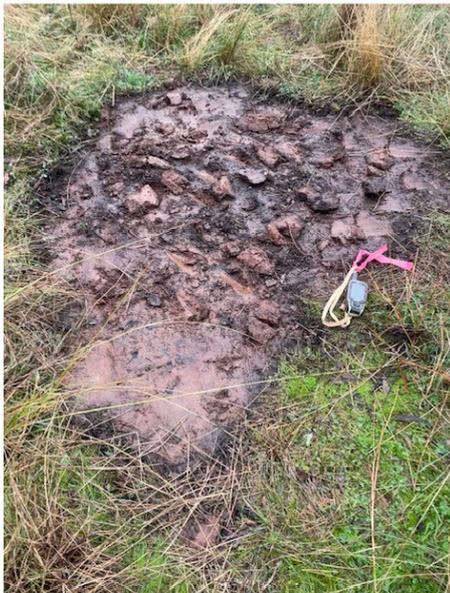
Figure 1 Minor diesel spill at site SDD002

- SDD001 – diamond drill hole, drilling completed and site rehabilitated
- SDD002 – diamond drill hole, drilling completed and site rehabilitated, evidence of small diesel spill observed on site
- SAC032 – air core hole, drilling completed and site rehabilitated

A minor oil or diesel spill was observed at site SDD002 (Figure 1). This spill was unlikely to result in material environmental harm and was not considered to be reportable under condition 7 of EL8153 because it was not reportable under the *Protection of the Environment Operations Act 1997*. The Krakatoa exploration manager was not previously aware of the spill but immediately cleaned up the area before the audit team left site. While Krakatoa had systems in place to identify and manage environmental incidents such as spills that were communicated to the driller during induction, the procedure was not implemented by the driller on this occasion. This was raised as observation of concern number 1. Krakatoa should ensure that contract drillers report and clean up any spills. Following the audit, the Krakatoa exploration manager advised he had followed up with driller to reinforce the requirement to report all spills and leaks.

It was noted that a minor diesel spill was observed at site SDD002 during the audit that was not reported by the driller to the Krakatoa exploration manager. Following the audit, the Krakatoa exploration manager advised he had spoken with the drilling contractor and reiterated the need to report all spills and incidents.

OBSERVATION OF CONCERN NO.	DESCRIPTION OF ISSUE	RECOMMENDATION
1	A minor diesel spill was observed at site SDD002. While Krakatoa had systems in place to identify and manage environmental incidents such as spills which were communicated to the driller during induction, the procedure was not implemented by the driller on this occasion.	Krakatoa should ensure that contract drillers are aware of the need to report and clean up any spills.

It was noted that following the audit, the Krakatoa exploration manager advised he had followed up with the driller to reinforce the requirement to report all spills and leaks.

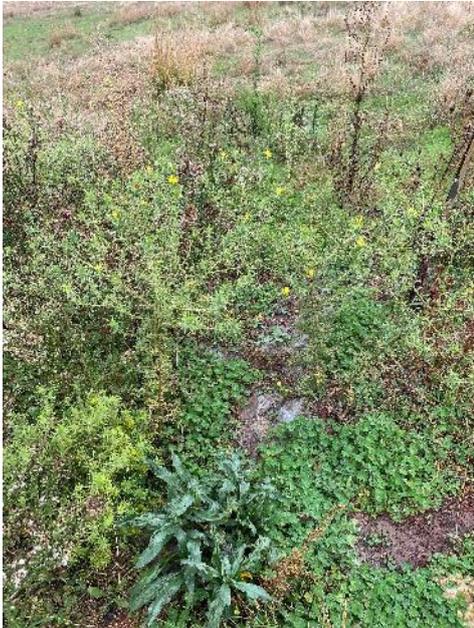
Figure 2 Weeds at site SDD001

Some weed growth was observed on the areas disturbed by drilling operations (Figure 2), but the weeds were consistent with weeds observed in other parts of the property unaffected by drilling operations. The Krakatoa exploration manager advised that the landholder was consulted and agreed to manage the weeds in conjunction with his own weed management activities over the remainder of the property.

The holes inspected during the audit were observed to be rehabilitated. Some minor weed growth was noted on the 2 diamond drill holes. The Krakatoa exploration manager advised that the diamond drill sites would be monitored over time and noted that the landholder had agreed to spray the weeds during spraying as part of the ongoing farm maintenance program.

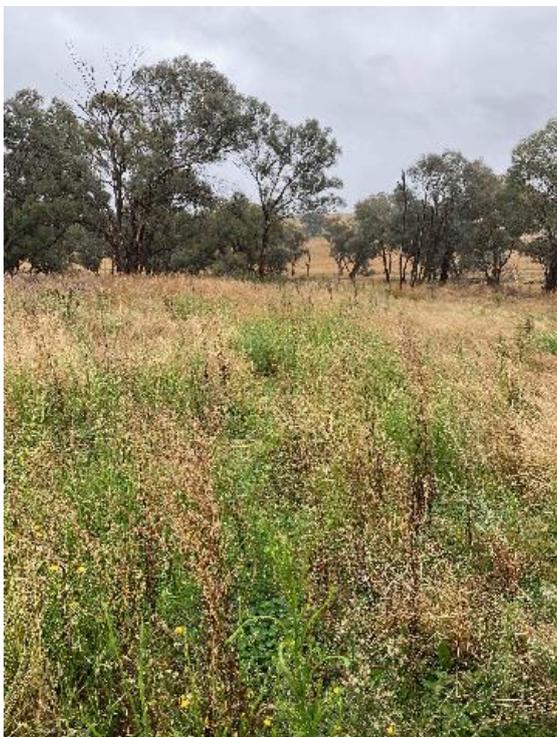
Figure 3 Rehabilitation of site SDD002

The aircore holes inspected had revegetated to be indistinguishable from the surrounding ground. Figures 3 and 4 show rehabilitation of a diamond hole and an aircore hole respectively.
