WEEKLY INCIDENT SUMMARY

Week ending Friday 9 September 2022

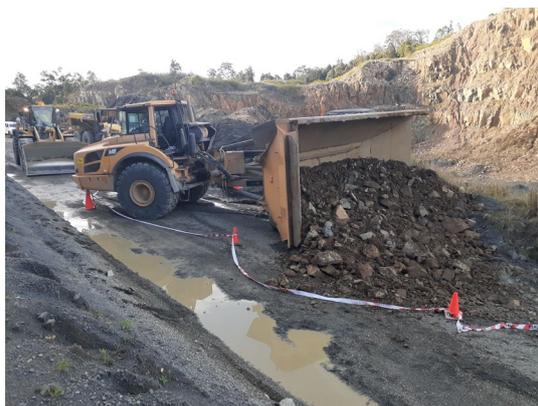
INCIDENT TYPE	SUMMARY	COMMENTS TO INDUSTRY
Dangerous incident IncNot0042957 Construction materials Roads or other vehicle operating areas	The tub of an articulated dump truck tipped over when it was backing onto a dump. As the rear wheels travelled over some soft, uneven material, the weight shifted and the tub rolled.	The stability of articulated vehicles is a known risk that needs to be managed at mine sites. Areas where loads are dumped should be constructed and maintained to ensure stable operations when tipping occurs. Refer to: Safety Bulletin SB18-07 Safe systems of work for mobile plant

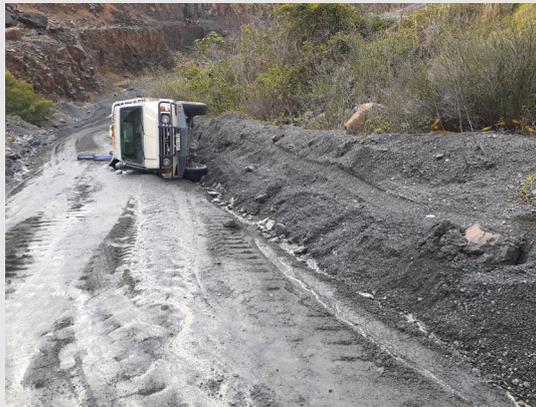
Dangerous incident
IncNot0042961
Construction
materials
Roads or other
vehicle operating
areas

A light vehicle was approaching an intersection, travelling uphill and intending to turn left. The driver changed his mind and decided to travel to the right. As he reversed the vehicle, the back wheels rode up onto a bund. The driver tried to drive off the bund while reversing. The vehicle rolled onto its side. The driver was uninjured.

Vehicle operators must always remain situationally aware and focused on controlling their vehicle, especially when reversing.

If contact is made with a bund when reversing, the driver should stop the vehicle and not continue to travel on the bund.

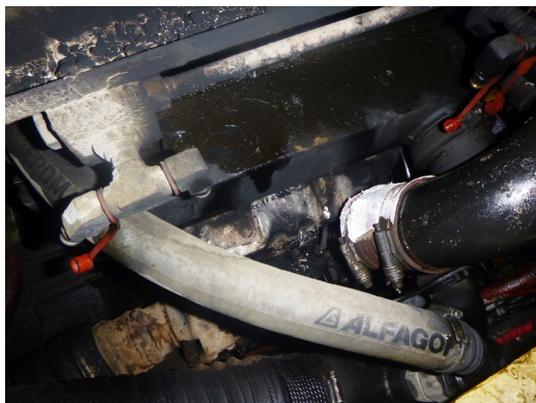
Dangerous incident
IncNot0042988
Underground
metals mine
Fire or explosion

A hydraulic hose on a spray rig failed while it was operating underground. Oil sprayed over the hot engine and ignited. A worker activated the onboard fire suppression system, which extinguished the fire.

The inspection and replacement of hydraulic hoses on mobile plant should be included in the mine's maintenance management system.

Pre-use inspections and scheduled maintenance works should include inspections for damage that may impact the integrity of fluid power systems and components.
