# Weekly incident summary

# Week ending 7 July 2023

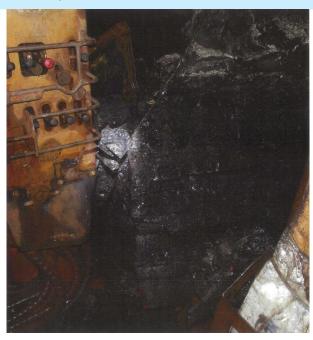
Dangerous Incident IncNot0044903 Underground coal mine

Airborne dust and other contaminants

A worker was using a mine dozer while cutting in a sump underground. During the shift, the dozer was used for 5 hours cutting the hard stone floor. During task planning, the risk of exposure to airborne contaminants must be considered.

When it is identified that stone is going to be cut such as sumps and overdrives, the hierarchy of controls should be followed. Controls such as worker segregation, ventilation, sprays, scrubbers and curtains should be implemented before personal protective equipment is considered.
