Weekly incident summary

Week ending 1 September 2023

This incident summary provides information on reportable incidents and safety advice for the NSW mining industry. To report an incident to the NSW Resources Regulator: phone 1300 814 609 24 hours a day, 7 days a week.

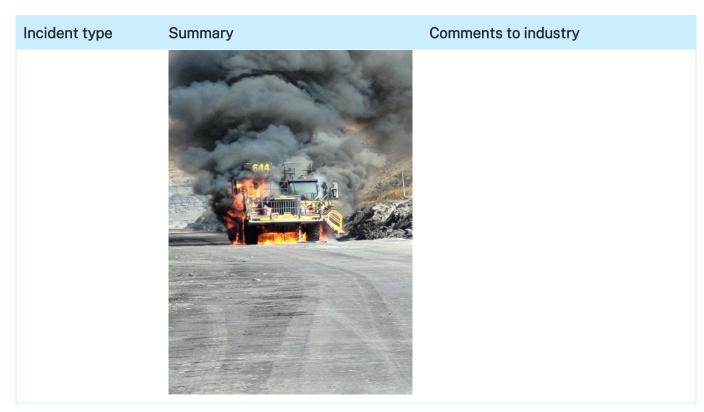
Incident type	Summary	Comments to industry
Severe incident IncNot0045312 Entanglement – Mechanical Engineering Control Plan	A worker's arm was amputated when it became entangled in the tail drum of a crusher conveyor. The worker was trapped for 4 hours while emergency medical procedures were undertaken.	This incident is under investigation and an investigation report will be released at a later date.
Dangerous incident IncNot0045309 Open cut coal Fire or explosion	A broken-down service truck caught fire while the truck was being towed. Most of the onboard fluids were drained from the service truck before it was towed.	A forensic fire expert has been engaged. Further findings may be communicated in future. Refer to :
	Once the fire was identified, the tow vehicle was disconnected but efforts to extinguish the fire failed.	 <u>MDG41 Fluid power systems</u> <u>MDG15 Guideline for mobile and</u> <u>transportable plant for use at</u> <u>mines (other than underground</u> <u>coal mines)</u> <u>Fire on mobile plant webpage</u>
