Weekly incident summary

Week ending 25 August 2023

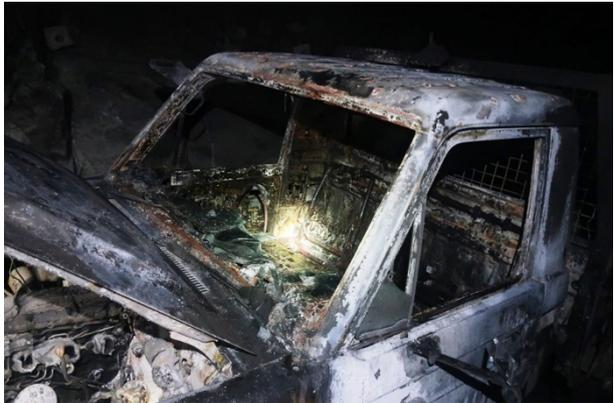
Incident type	Summary	Comments to industry
Dangerous incident IncNot0045278 Underground metals mine Fire or explosion	<p>A light vehicle was being driven to a drill rig when it stopped about 80 metres from the drill site. A worker proceeded to the drill rig and commenced work. The worker heard a bang and turned to see the vehicle on fire. The worker used an extinguisher and found the fire suppression system had already activated. This did not extinguish the fire.</p> <p>The worker retreated and raised the alarm. All workers then proceeded to refuge chambers. The mine's emergency rescue team responded to the fire.</p>	A forensic fire expert has been engaged. Further findings may be communicated in future.

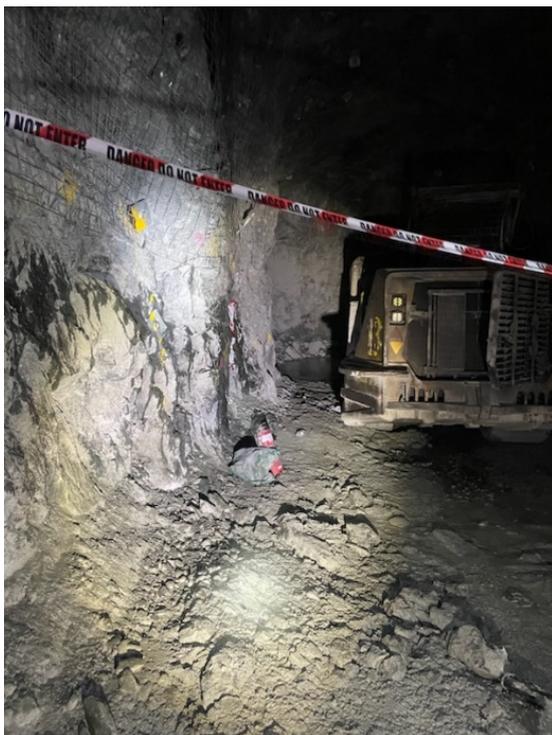
Incident type	Summary	Comments to industry
<p>Dangerous incident IncNot0045290 Underground metals mine Fire or explosion</p>	<p>A worker was cleaning up in a decline and noticed a red glow at the back of a loader. The worker activated the fire suppression system, which extinguished the fire. A fire extinguisher was also used to ensure the fire was extinguished.</p> <p>An initial inspection determined that an oil cooler hose failed and sprayed oil onto the fan and the turbo. This was supported by the spray of oil on the ground and wall.</p>	<p>Managing hydraulic hoses is vital in reducing the risk of fire on mobile plant. Hoses near fans should be considered high risk due to the dispersion of any oil if a hose fails.</p> <p>Refer to:</p> <ul style="list-style-type: none">• MDG41 Fluid power systems• MDG15 Guideline for mobile and transportable plant for use at mines (other than underground coal mines)• Fire on mobile plant webpage
