# Compliance audit program

ML 1773 and ML1825 – Pineleigh Quarry

**Tastex Pty Ltd**

December 2023

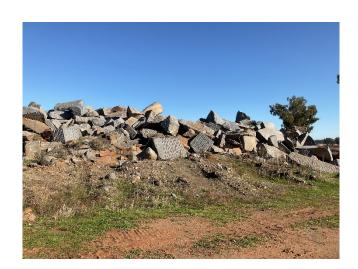
Observations made during the site inspection (Figure 1 and Figure 2) confirmed that quarry operations were generally undertaken in accordance with the description of operations in the MOP.
