# INVESTIGATION INFORMATION RELEASE

AUGUST 2019

## Improving progressive rehabilitation at Whitehaven's open cut coal mines

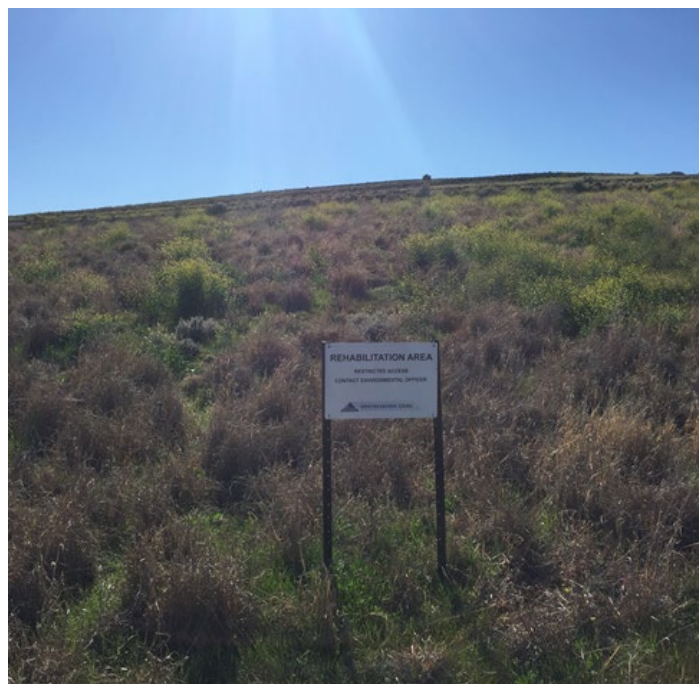
Figure 1 shows poor revegetation at Tarrawonga. This area was shaped five to six years ago, with an open woodland rehabilitation objective.

*Figure 1 Tarrawonga Coal Mine's poorly wooded revegetation*

This photograph shows no visible signs of established tree species. Rather, the rehabilitation area has a thick cover of exotic grasses and weed species. Under these circumstances, establishing a woodland area would be difficult and resource intensive.

The Regulator has issued statutory notices pursuant to section 240(1)(c) of the *Mining Act 1992* to Whitehaven Coal Mining Ltd requiring it to engage suitably qualified experts across its four operations (Tarrawonga, Rocglen, Sunnyside and Maules Creek) to:

- provide information regarding the status of progressive rehabilitation
- advise whether progressive rehabilitation has been undertaken in accordance with approved plans and strategies
- identify measures or actions to improve progressive rehabilitation performance

- submit a report to the Regulator that includes a timeline to improve progressive rehabilitation at each site.

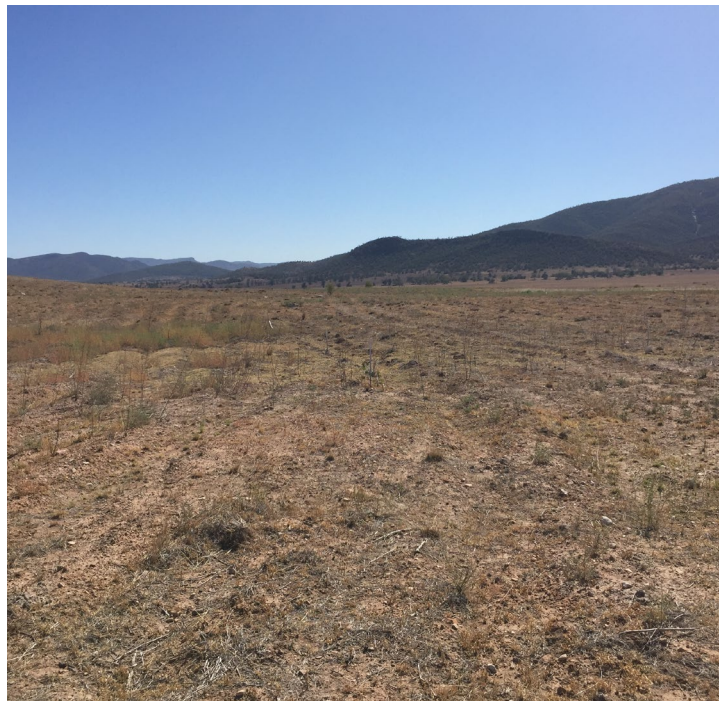
Figure 2 depicts the third attempt of woodland revegetation at the Rocglen Mine Northern Emplacement Area. Its target rehabilitation objective was open woodland. This area is three to five years old and is **not progressing well**. Tubestock has been planted in this area on three occasions without success.

*Figure 2 Woodland revegetation at Rocglen Mine*
