# SAFETY ALERT

## Working at heights

### INCIDENT

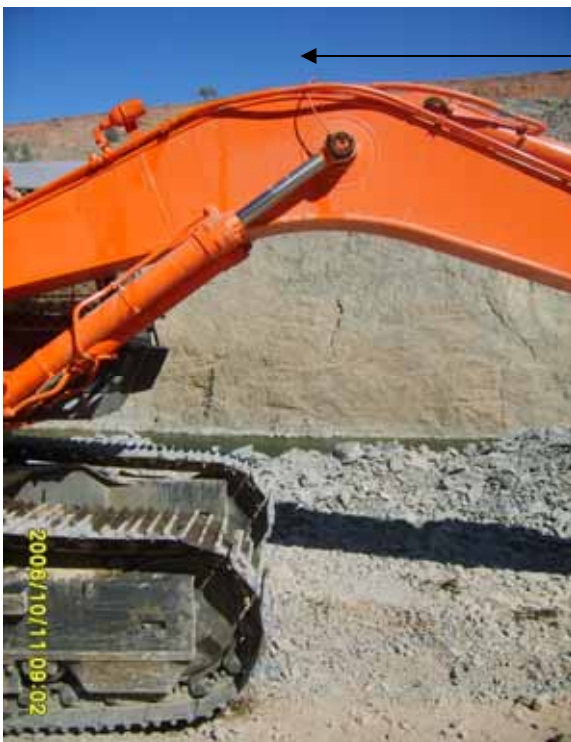
An excavator operator slipped and fell approximately 3.5 metres to the ground while undoing a hydraulic fitting on the top of the excavator boom. He sustained serious injuries to his left leg and right pelvis.

The operator fell approximately 3.5 metres from the top of the excavator boom to the ground.

The operator was in the process of repairing a leaking hydraulic fitting on the excavator boom. During the process of undoing a hydraulic coupling on the boom, the operator slipped and fell approximately 3.5 metres to the ground.

- The operator was not wearing fall protection and did not have a fit-for-purpose work platform from which to work.
- No JSA or risk assessment was undertaken prior to commencing the repair work.
- The boom of the excavator could have been lowered to provide a safe work location, eliminating the need to climb up the boom.
- It appears the hydraulic pipe running up the boom may not have needed to be removed to repair the oil leak.

1. Implement safe systems for work at heights.
2. Instruct and train employees in these safe work systems.
3. Enforce these safe systems through supervision and discipline.
