SAFETY ALERT

Fluid injection from high pressure water cleaning

ABN 72 189 919 072 www.resources.nsw.gov.au/safety Mine Safety Alert No: SA14-03 File No:11/6055 Comet ID: 317632097001 Prepared by: G Johnston Phone: 02 42228307 Date Published: 26 March 2014

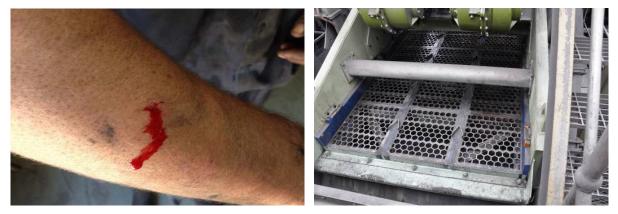
An operator was attempting to clean build-up off a screen using a high pressure water cleaner. The operator was working in a restricted and cramped area when he tripped and dropped the lance (jetting gun). The jetting gun failed to automatically shut off. This allowed high pressure water to hit the operator on the forearm. The operator was transported to medical aid where his injury was identified as a fluid injection.

Injury to worker's forearm (left) and the cramped working conditions (right).

- 1. The working area was restricted and cramped.
- 2. The high pressure water cleaning equipment was not fitted with an emergency stop or emergency shutdown function.
- 3. The automatic shut-off function (hold on to activate) on the jetting gun failed to operate due to possible contamination from
 - a. Supply water being unfiltered.
 - b. Quick release couplings on the jetting gun and flexible hose were not capped during storage.
- 4. No safety observer was present.
- 5. The working area was not barricaded.
- 6. The operator was not wearing the correct personal protection equipment (PPE) appropriate to the degree of risk.

- 1. Where any high pressure water cleaning (jetting) activities are intended to be carried out on a mine site, consideration should be given to the following to assist in the identification of hazards and implementation of appropriate risk control measures

- c. AS/NZS 4233.2:2013 High pressure water jetting systems Part 2: Construction and performance
- 2. High pressure water jetting equipment should be
 - a. Defect free, fit for purpose and fitted with all recognised safeguards.

- b. Subject to pre-use and periodic equipment inspections to ensure it remains in a condition that is safe to use.
 - c. Identified if energy output is Class A or Class B equipment, see AS/NZS 4223.1:2013.

- 3. Any area in close proximity to high pressure water jetting should be barricaded to prevent inadvertent interaction of high pressure fluid equipment and people.

- 4. All operators and assistants of high pressure water jetting systems should be trained in the safe use of the equipment by competent people in accordance with AS 4233.1:2013.
