## **SAFETY ALERT**

### **BATTERY EXPLOSION INJURES EMPLOYEE**

Report No: SA 00-26

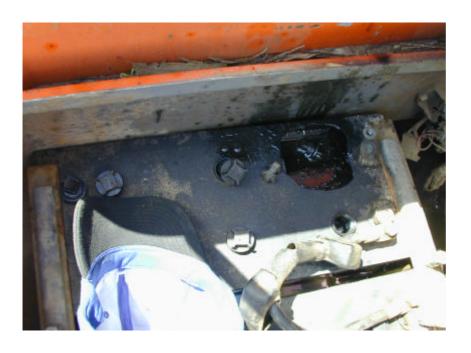
The employee did not remove the excavator batteries from their box. This allowed hydrogen gas to collect around the batteries during charging. Hydrogen gas is very explosive. When the employee disconnected the charger from the battery, an electric spark ignited the hydrogen.

The resulting explosion blew off several battery vent caps and a piece of battery casing. Battery acid sprayed the employee's face and eyes, and the piece of casing cut him on the head.

- The batteries were not removed from mobile equipment battery box to be charged (as the operation manual said).
- The batteries were not charged in a well-ventilated area.
- The charger was not switched off or disconnected from mains power supply.
- The employee was not wearing appropriate personal protective equipment.
- The employee had not been trained in the correct procedure for battery charging.

The photo shows the battery after the explosion.

The dark circle on the right is the hole in the battery casing which was blown off.

The cap on the bottom left of the photo gives an idea of how big the piece of casing was.

- 1. Risk reviews should be undertaken to identify hazards associated with charging of batteries.
- 2. Safe working procedures should be developed and relevant employees trained in the safe operation, maintenance and charging of batteries for mobile equipment.
