Safety bulletin

Windrow management and demarcation

This safety bulletin provides safety advice for the NSW mining industry on managing the risks of with plant working near windrows.

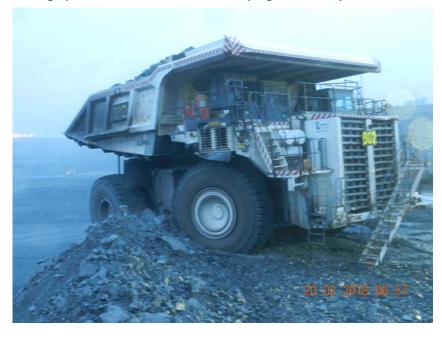
Photograph 1: A haul truck was rear dumping when the operator reversed over windrow. Photo courtesy of the mine.

- 1. Design and construct windrows adequately to be a control for the hazard at the operation, paying specific attention to set-back distances, heights and material used.

- 2. Regularly inspect and maintain windrows through open cut examiner inspections and operator inspections.
- 3. Acknowledge that windrows should be used as a line of demarcation rather than an interception for vehicles.

- 6. Vehicles operating around windrows should operate in such a way to ensure the windrows have maximum efficiency including the angle at which equipment operates in relation to the windrow.

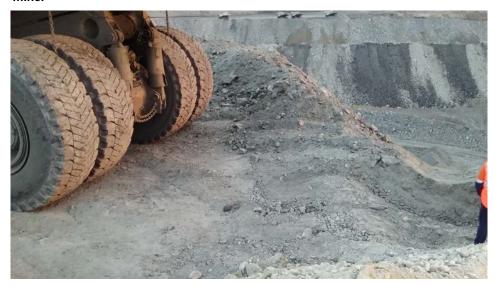
Photograph 2: During rear dumping the windrow has packed down, reducing its effectiveness. Photo courtesy of the mine.

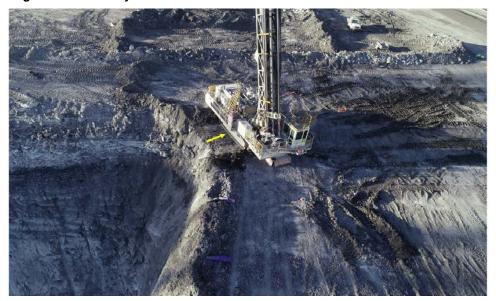
Photograph 3: The drill rig has trammed over windrow, showing the rig's position after it was pulled back from the edge. Photo courtesy of the mine.

- Highwall demarcation should be established on drilling benches including adequate use of lighting, flashing beacons or reflective signs as deemed appropriate to ensure operator awareness.
